**SURVEY FOR ENDANGERED MUSSELS IN LITTLE
TALLAPOOSA RIVER AND BIG INDIAN CREEK AT PROPOSED
WATER INTAKES, CARROLL COUNTY, GEORGIA**

September 2008

DBC Project 1156

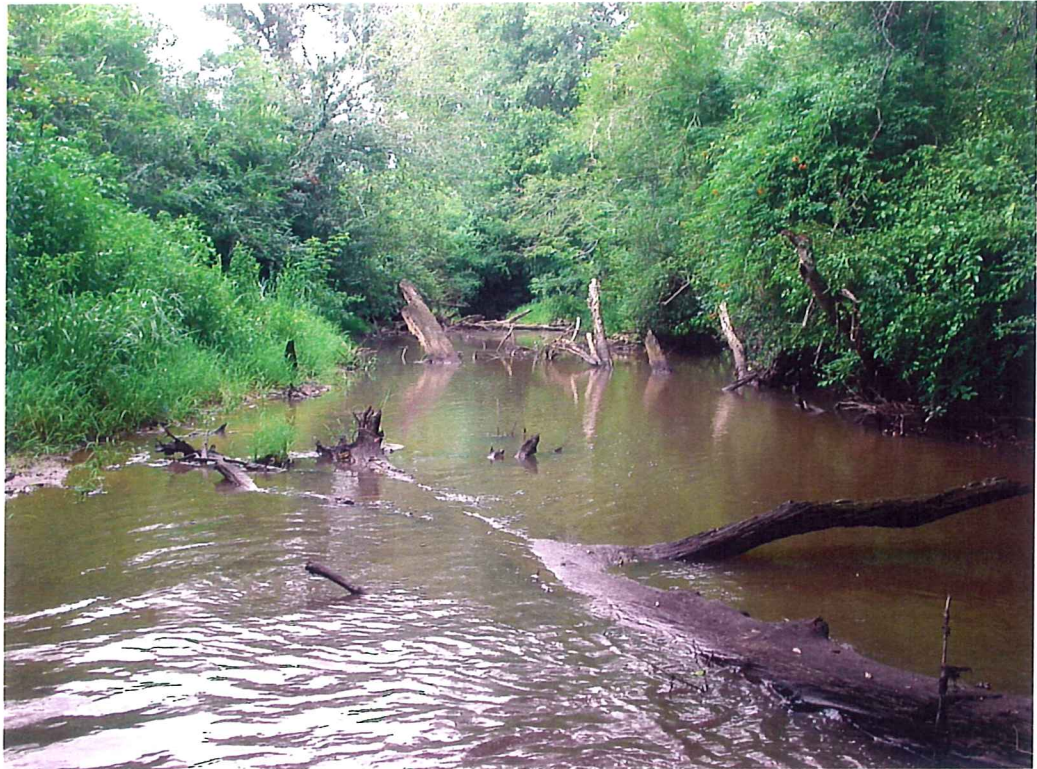
Picture B-5: Big Indian Creek, approximately 1,000 ft downstream of proposed intake, Carroll County, Georgia. View looking upstream from center of channel. 23 July 2008.

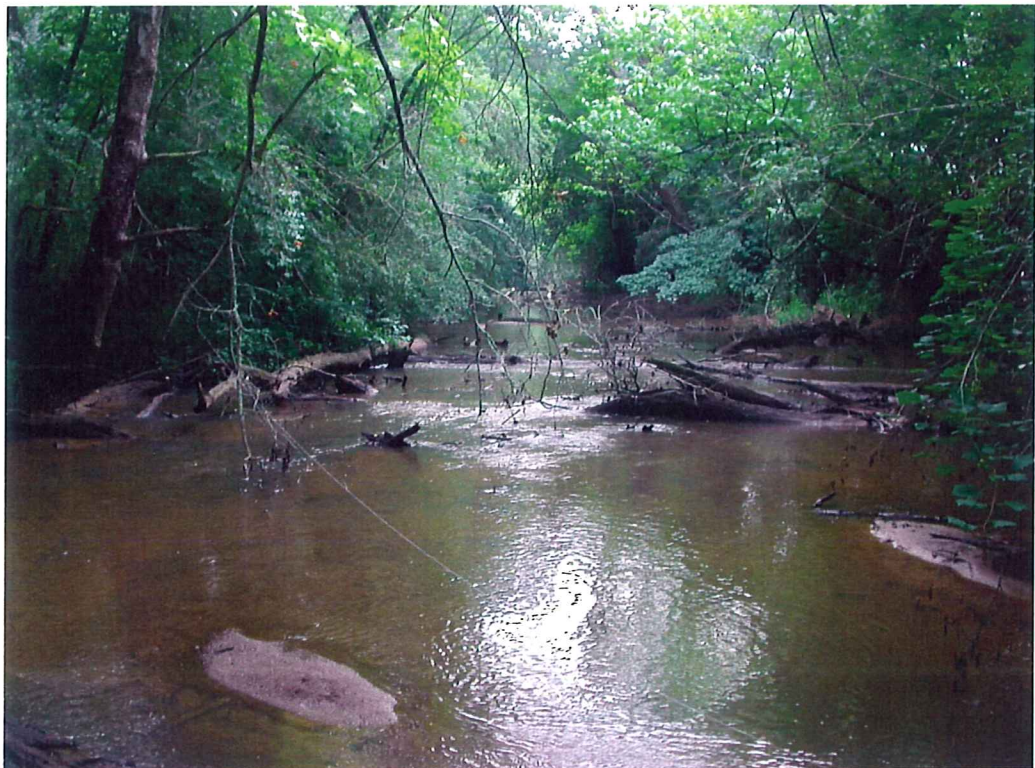
Picture B-6: Big Indian Creek, approximately 1,000 ft downstream of proposed intake, Carroll County, Georgia. View looking downstream from center of channel. 23 July 2008.

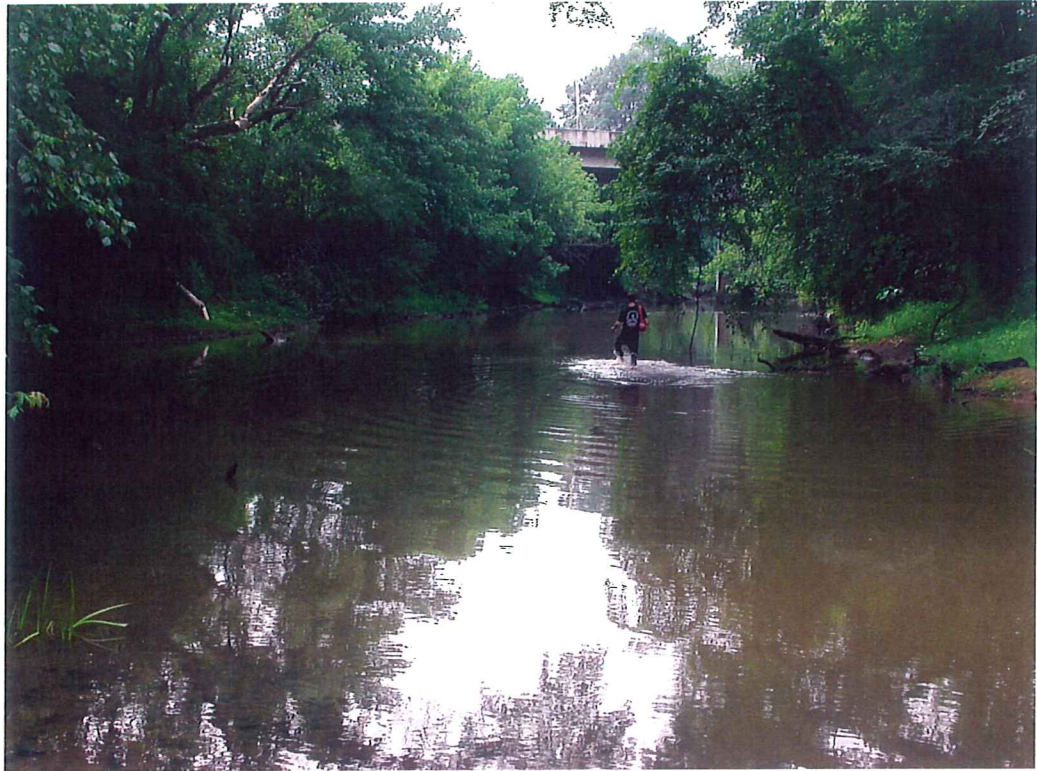
Picture B-3: Little Tallapoosa River at site of proposed intake (lower study reach), Carroll County, Georgia. View looking upstream from center of channel. 22 July 2008.

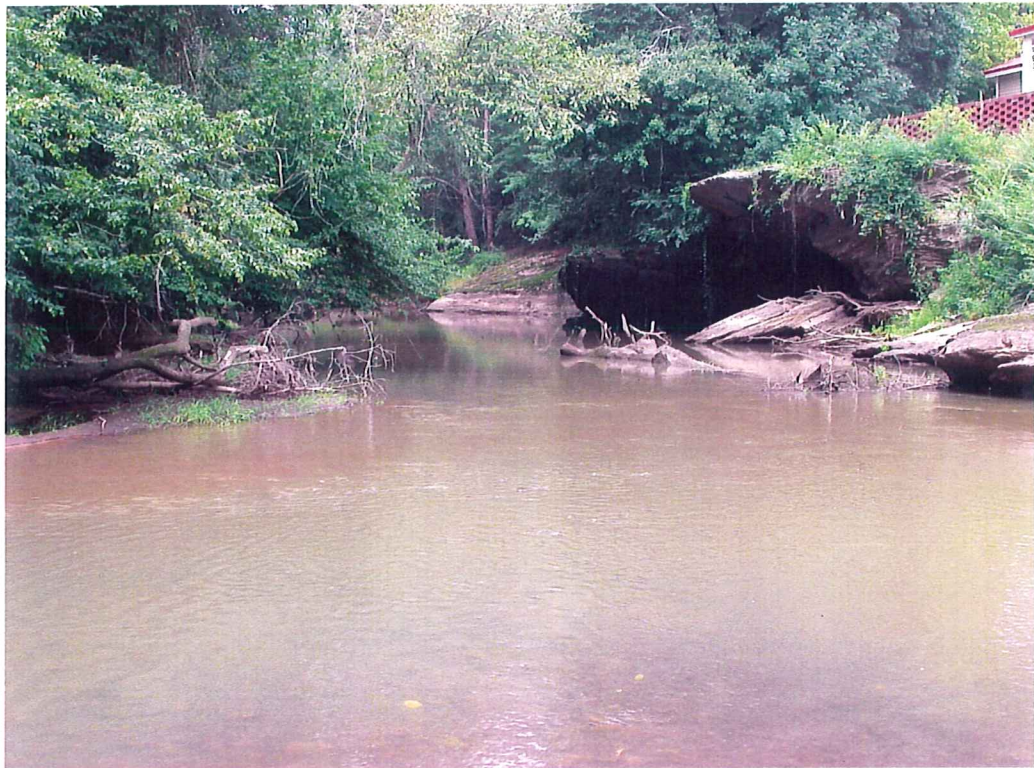
Picture B-4: Little Tallapoosa River at site of proposed intake (lower study reach), Carroll County, Georgia. View looking downstream from center of channel. 22 July 2008.

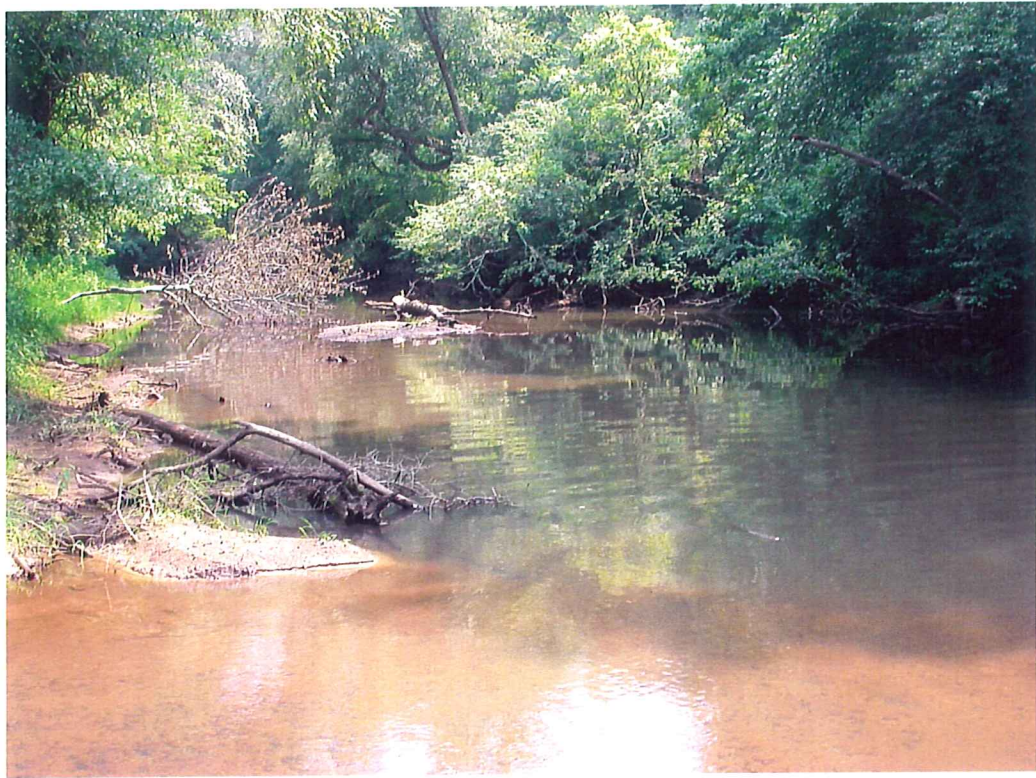
Picture B-1: Little Tallapoosa River at site of proposed intake (upper study reach), Carroll County, Georgia. View looking upstream from center of channel. 22 July 2008.

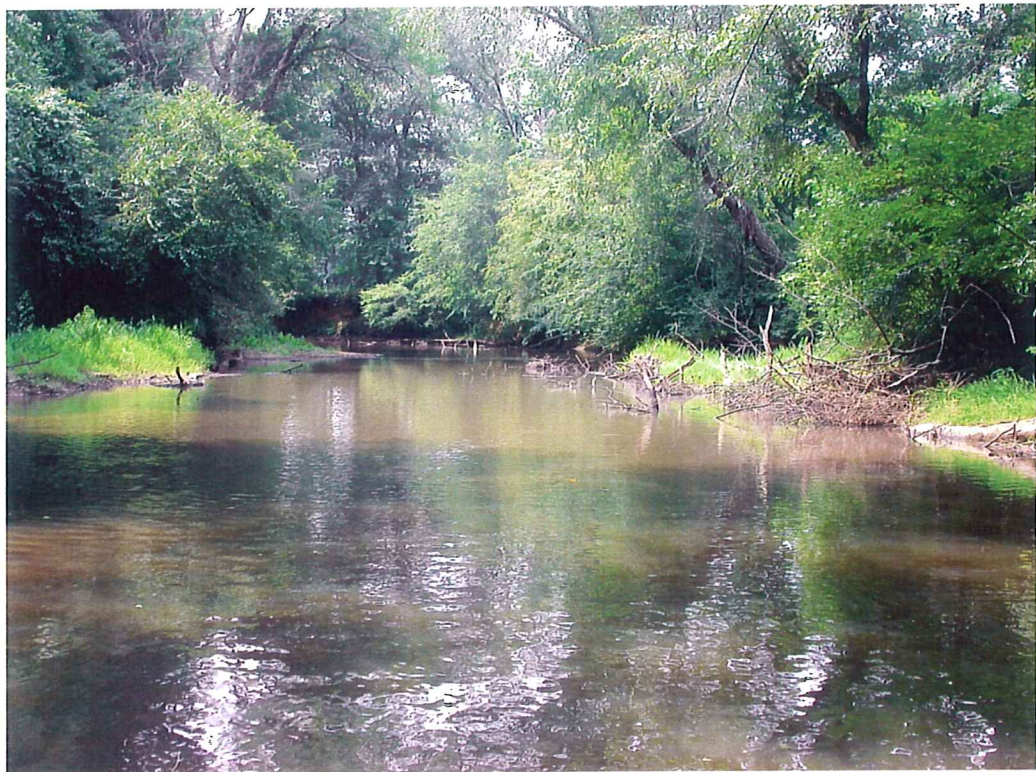
Picture B-2: Little Tallapoosa River at site of proposed intake (upper study reach), Carroll County, Georgia. View looking downstream from center of channel. 22 July 2008

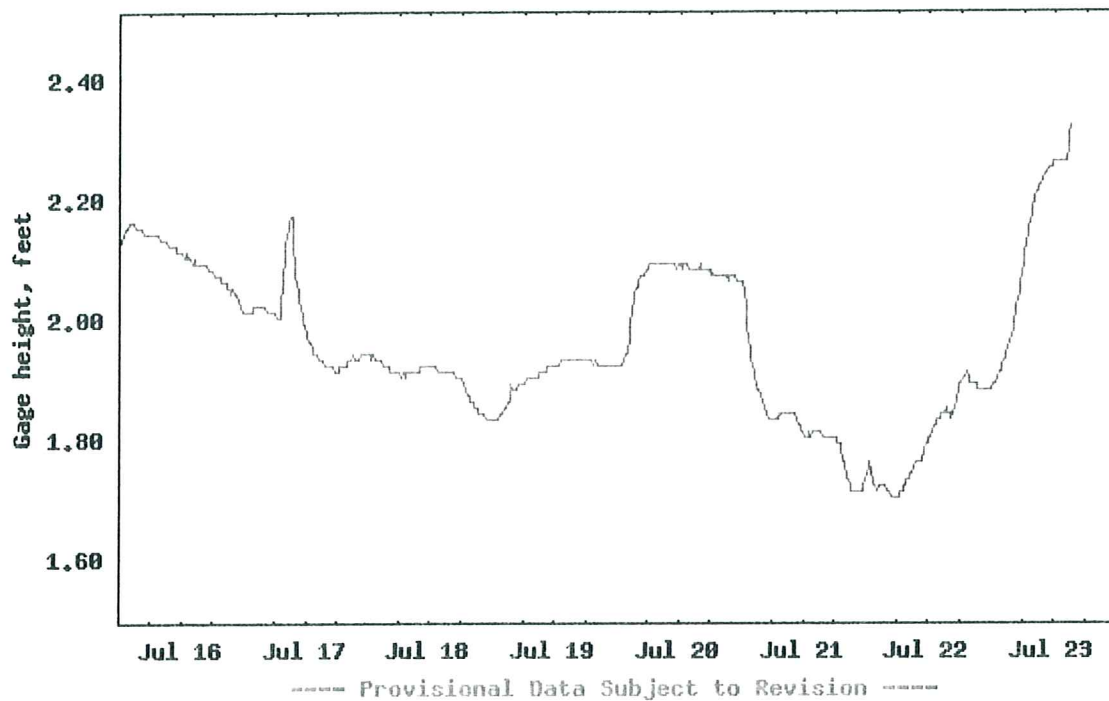
Gage height, feet

Most recent instantaneous value: 2.32 07-23-2008 15:00

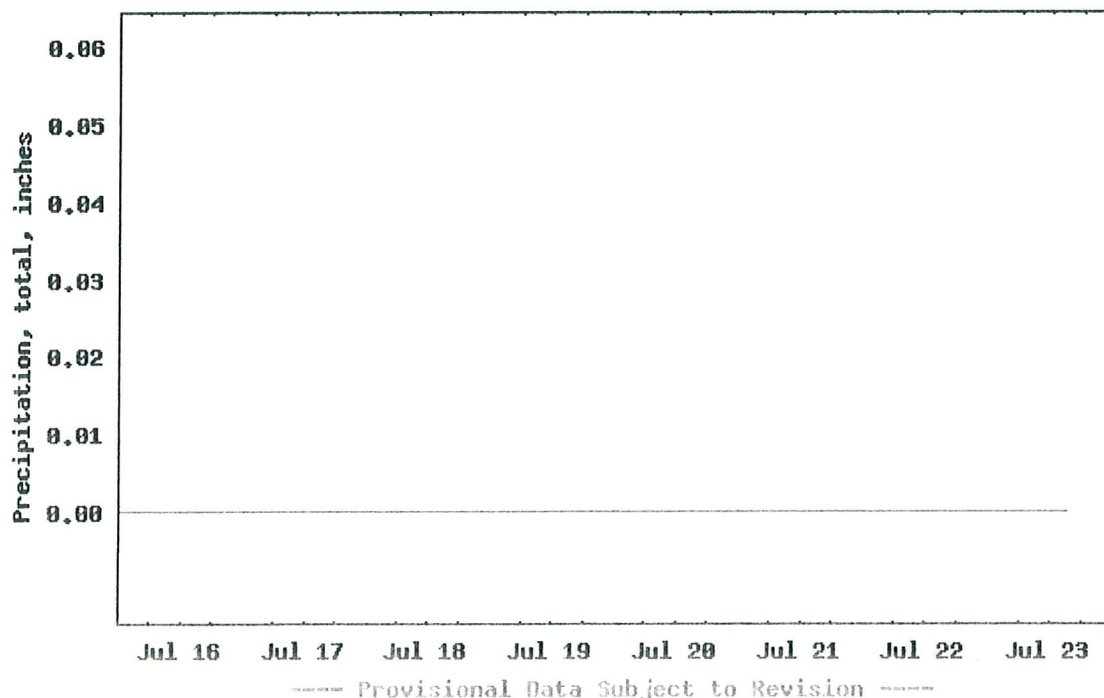
Precipitation, total, inches

Most recent instantaneous value: 0.00 07-23-2008 15:00

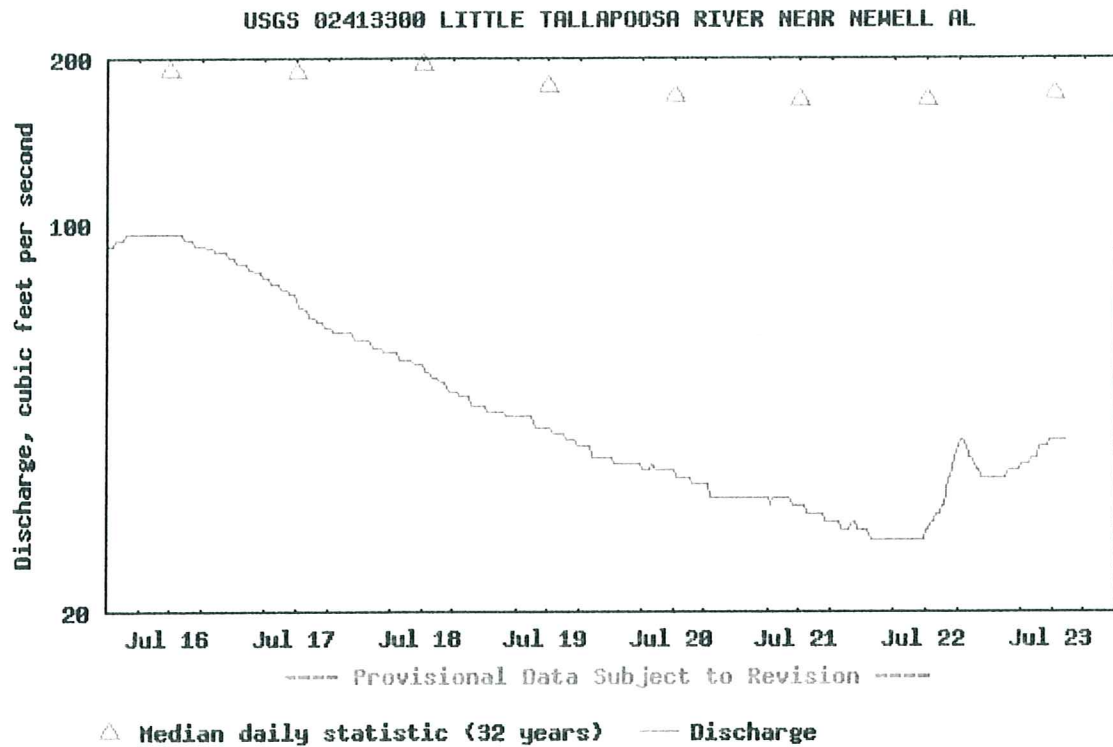
Discharge, cubic feet per second

Most recent instantaneous value: 41 07-23-2008 14:30

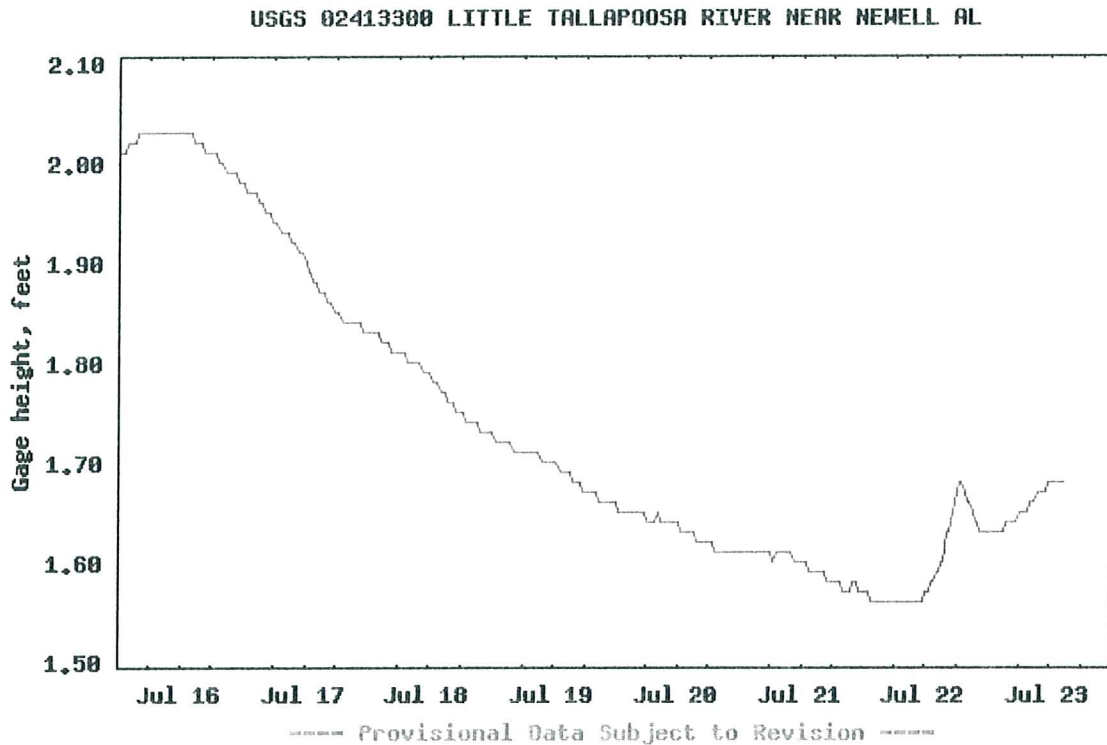
Gage height, feet

Most recent instantaneous value: 1.68 07-23-2008 14:30
